ASSETGUARD polyurea eliminates leaks on salt water disposal

Polyurea offered by ASSETGUARD eliminated leaks on failing SWD with minimal maintenance and downtime

San Augustine, Texas, USA

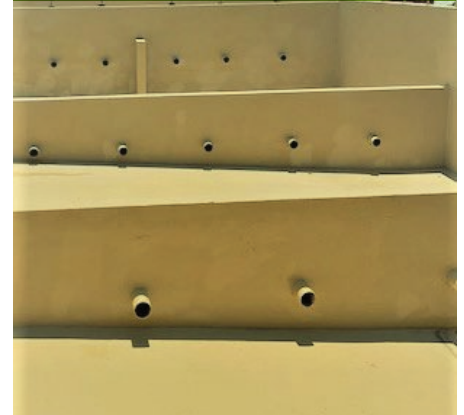
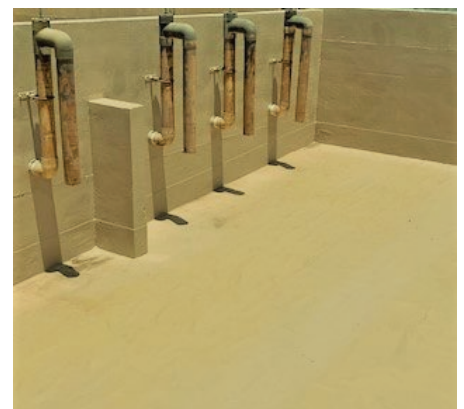
An in-ground 50' x 110' concrete salt water disposal facility with three interior walls spaced evenly across the width had multiple minor cracks and one major crack, which were all leaking water into the SWD. A solution was needed to stop the fluids from seeping into the facility. A liner system was required that would stop the leaks and last for an extended period with minimal maintenance. The decision was made with the client to use a modified polymer system as a liner for the installed concrete.

After following proper surface preparation procedures to ensure complete adhesion to the concrete surfaces, the interior walls and floor of the SWD were lined with ASSETGUARD proprietary polyurea to create an impermeable barrier. As part of the surface preparation process, tests were conducted to ensure that salt residue was within acceptable limits. A proprietary primer was used, and upon complete curing the polyurea was sprayed to the entire facility. Finally, testing was performed.
