GROUNDGUARD chosen to prevent water loss due to poor soil conditions around canal gate

Crawford, Colorado, USA

Application: Rural Ditch and Canal Water Management

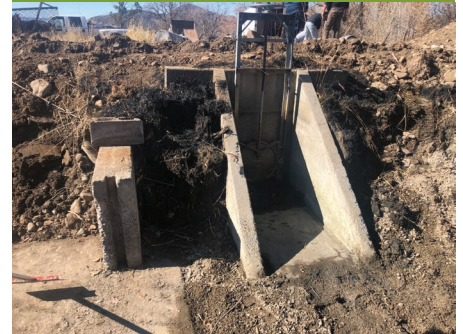
Poor soil conditions allowed erosion and build-up of debris at the canal gate and check gate.

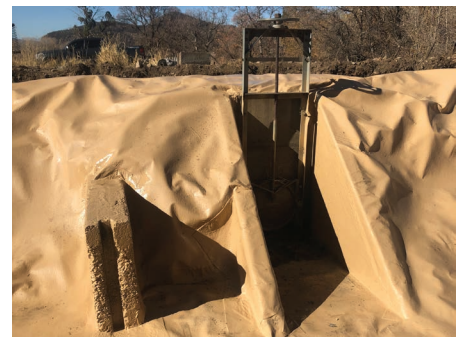
GROUNDGUARD liner sealed to the concrete structure will minimize erosion and seepage, preventing water loss.

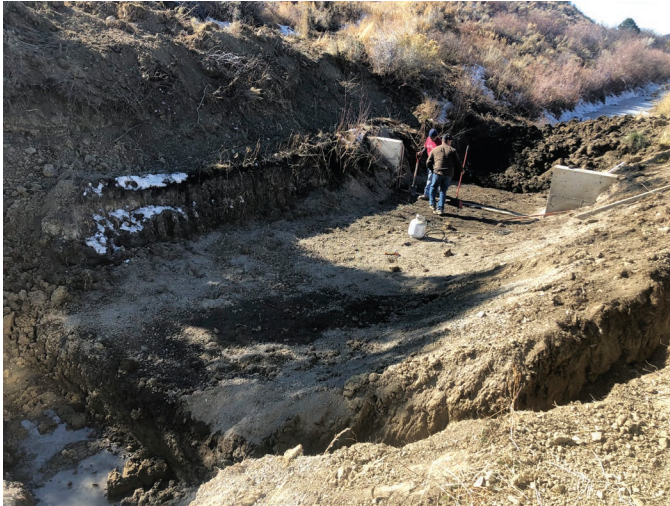
Before

Area 1 before GROUNDGUARD installation.

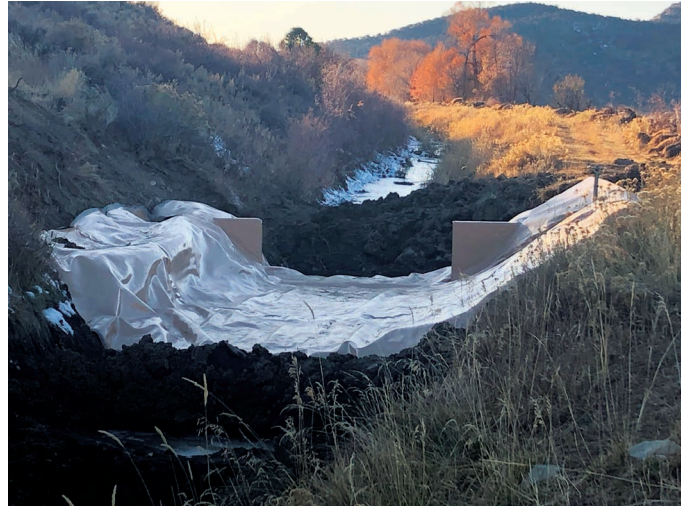
After

Area 1 after GROUNDGUARD installation.

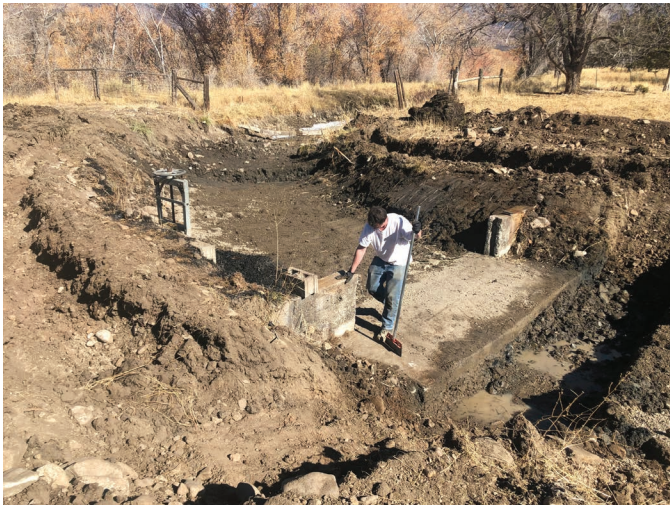
Before

Area 2 before GROUNDGUARD installation.

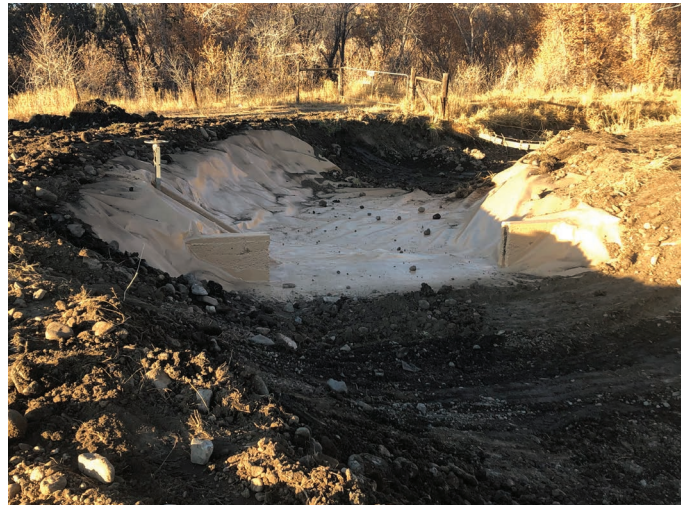
After

Area 2 after GROUNDGUARD installation.
