# FALCON Technologies polyurea eliminates leaks on salt water disposal

Polyurea offered by FALCON eliminated leaks on failing SWD with minimal maintenance and downtime

## San Augustine, Texas, USA

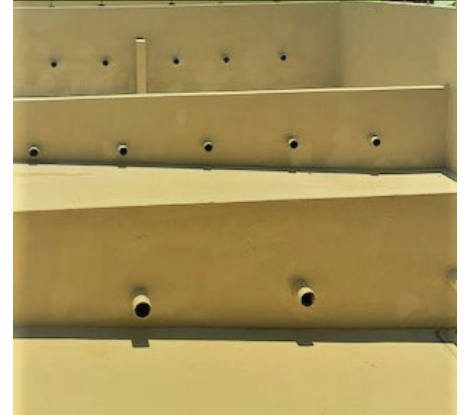
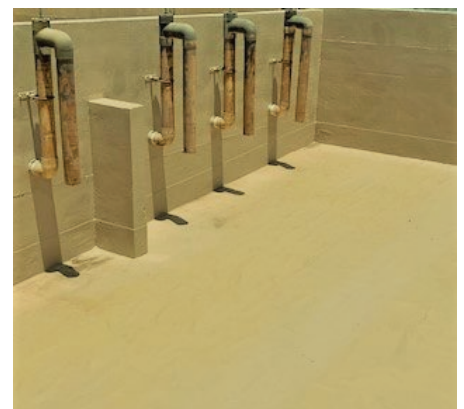
An in-ground 50' x 110' concrete salt water disposal facility with three interior walls spaced evenly across the width had multiple minor cracks and one major crack, which were all leaking water into the SWD. A solution was needed to stop the fluids from seeping into the facility. A liner system was required that would stop the leaks and be long-lasting with minimal maintenance. The decision was made with the client to use a modified polymer system as a liner for the installed concrete.

After following proper surface preparation procedures to ensure complete adhesion to the concrete surfaces, the interior walls and floor of the SWD were lined with FALCON proprietary polyurea to create an impermeable barrier. As part of the surface preparation process, tests were conducted to ensure that salt residue was within acceptable limits. A proprietary primer was used, and upon complete curing the polyurea was sprayed on the entire facility. Finally, testing was performed to ensure complete and consistent coverage with the polyurea.
